Final Completion Report – Reach 5B

Kress Creek/West Branch DuPage River Site and
the River Portion of the Sewage Treatment Plant
Site

**Final Completion Report –
Reach 5B**

Kress Creek/West Branch
DuPage River Site and the River
Portion of the Sewage Treatment
Plant Site

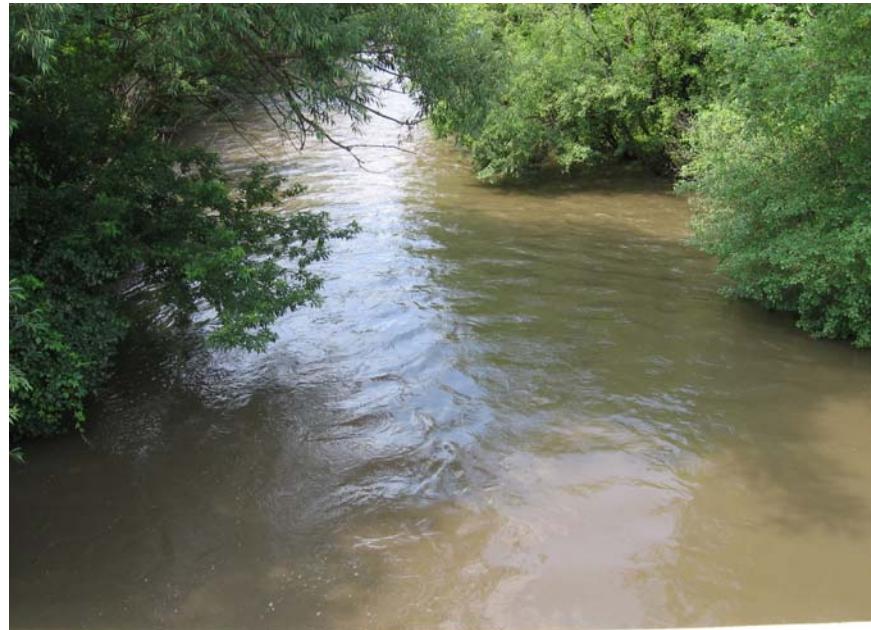
Preconstruction photo showing heavily wooded riverbanks.

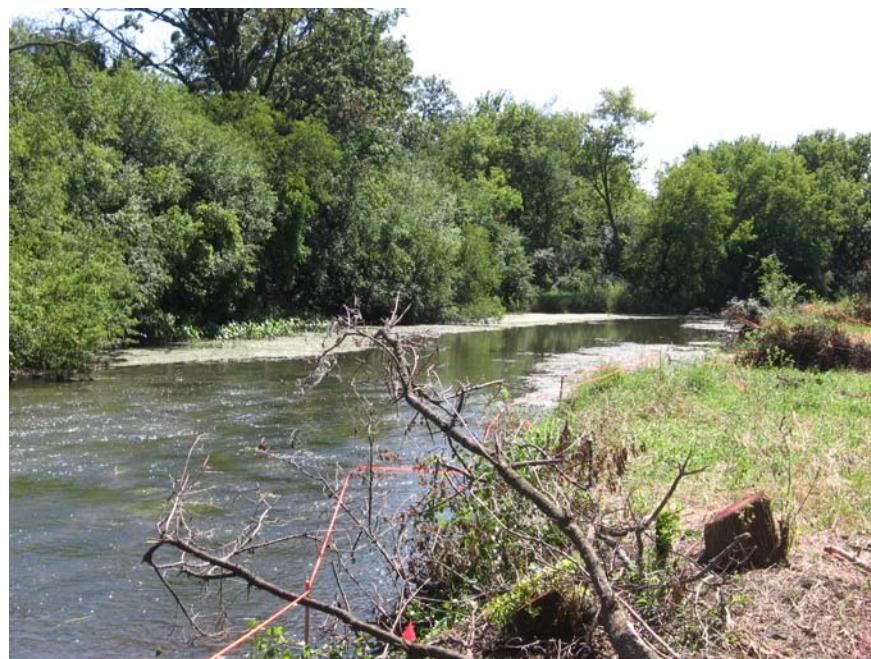
Looking along west bank after clearing, prior to excavation.

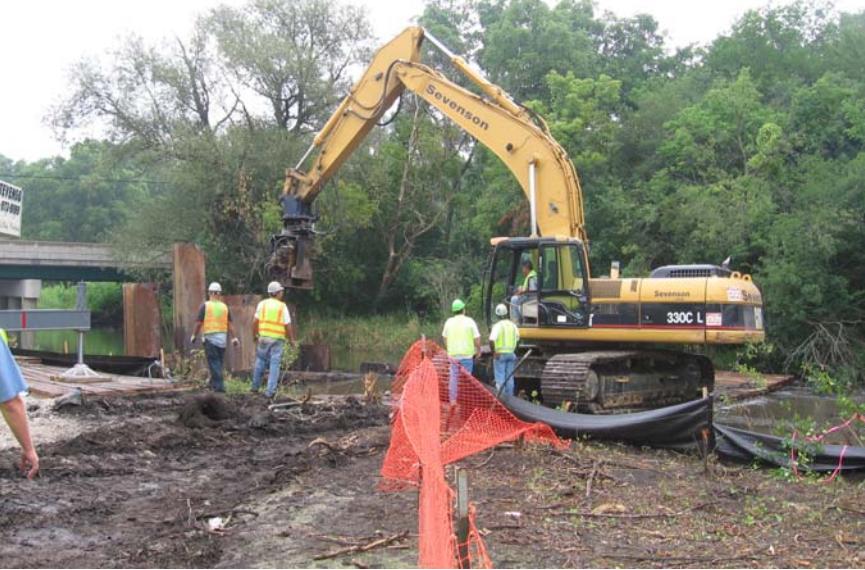
Direction: Standing at bypass pump staging area, looking northeast	
Comments: MoVax equipment installing sheetpiling for bypass sump.	
Photographer: Mike Savage Arcadis	
Date: August 19, 2006

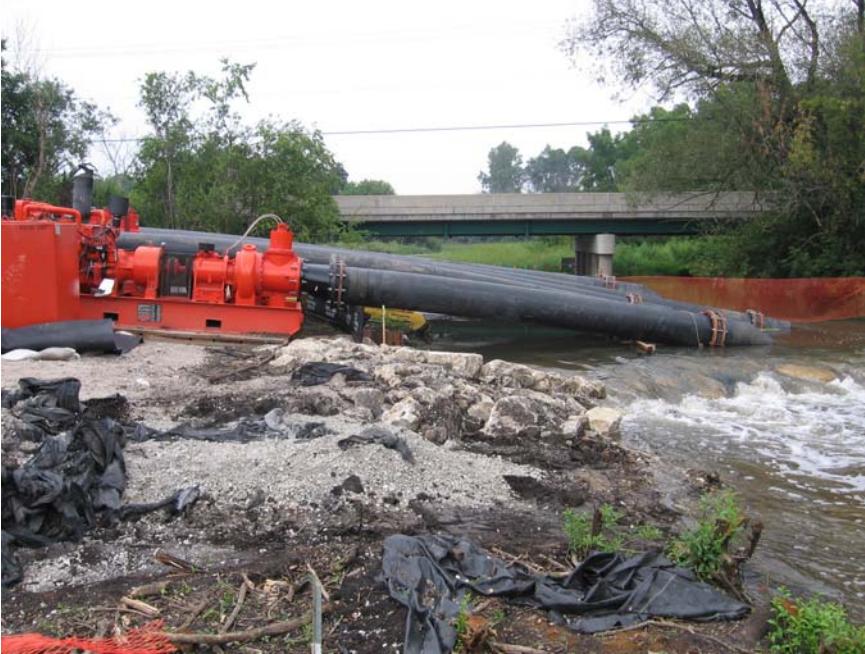
Direction: Looking north	
Comments: Looking at bypass pumps with suction piping extending into bypass sump in river.

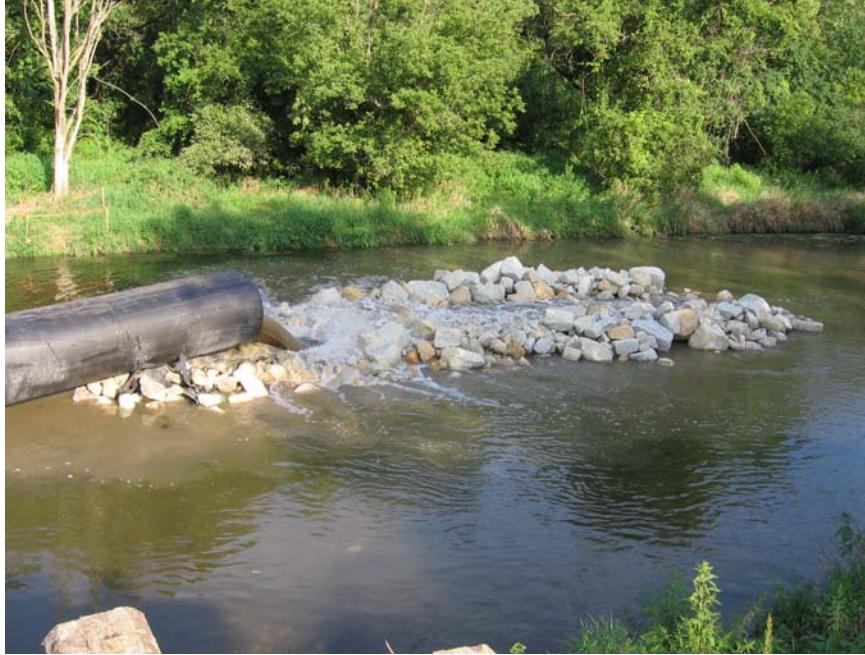
Date: August 21, 2006	
Direction: Looking southeast	
Comments: Standing at South end of Reach 5B on west bank, looking at discharge of bypass pipe to the in-river velocity dissipation system.	
Photographer: Rick Elia Jr. Sevenson Environmental Services, Inc.

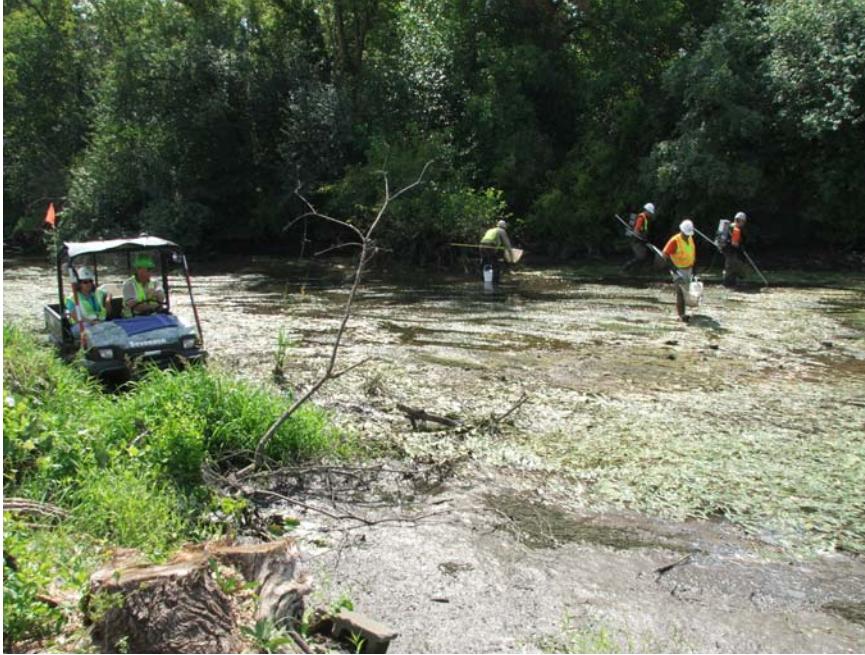
Date: August 22, 2006	
Direction: Looking east	
Comments: Fish shocking activity to capture and relocate fish during startup of bypass pumping operation.

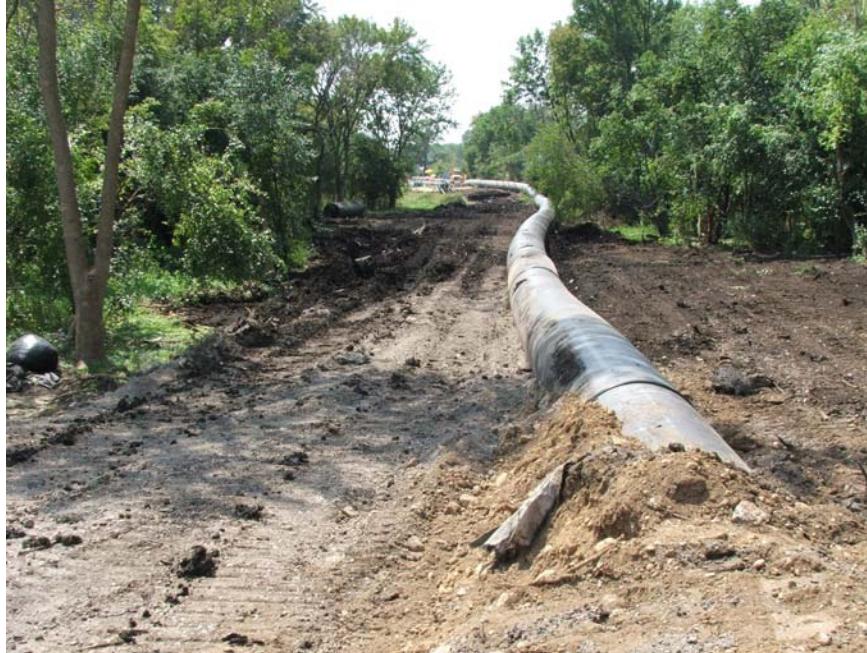
48" diameter bypass
piping installed in
cleared pipe corridor.

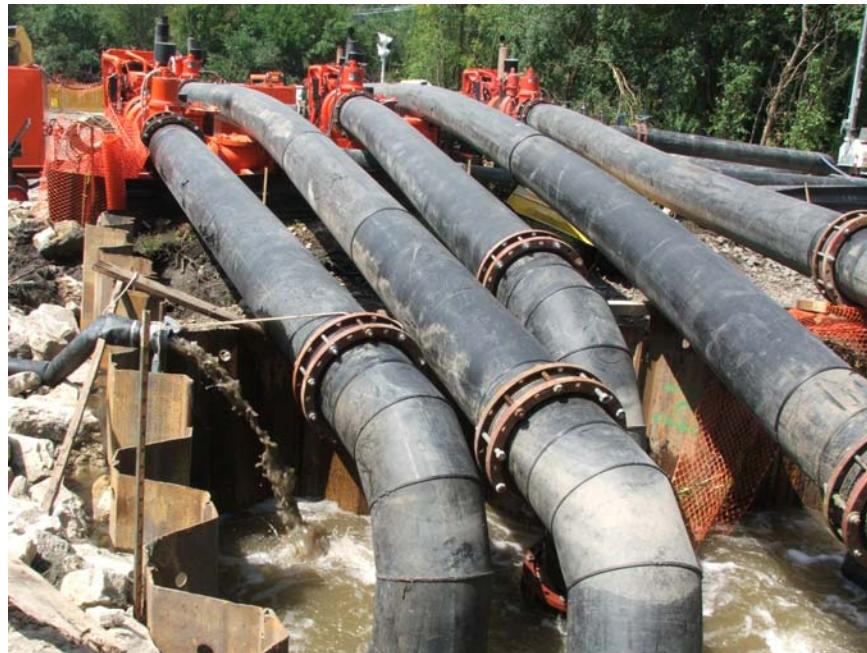
The five bypass pumps
with their separate
suction pipes extending
into bypass sump in
river.

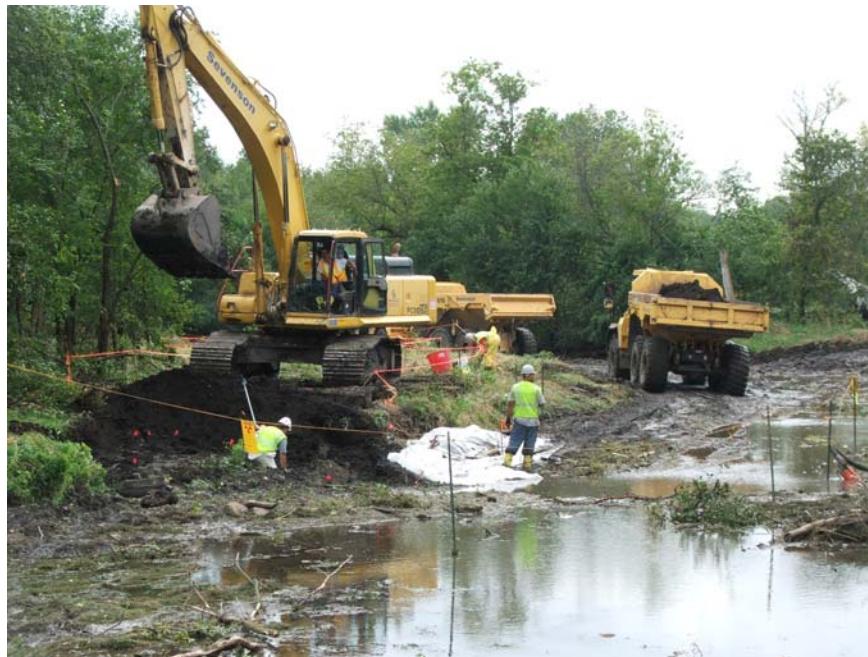
Excavation of targeted material from bank of bypassed section of river.

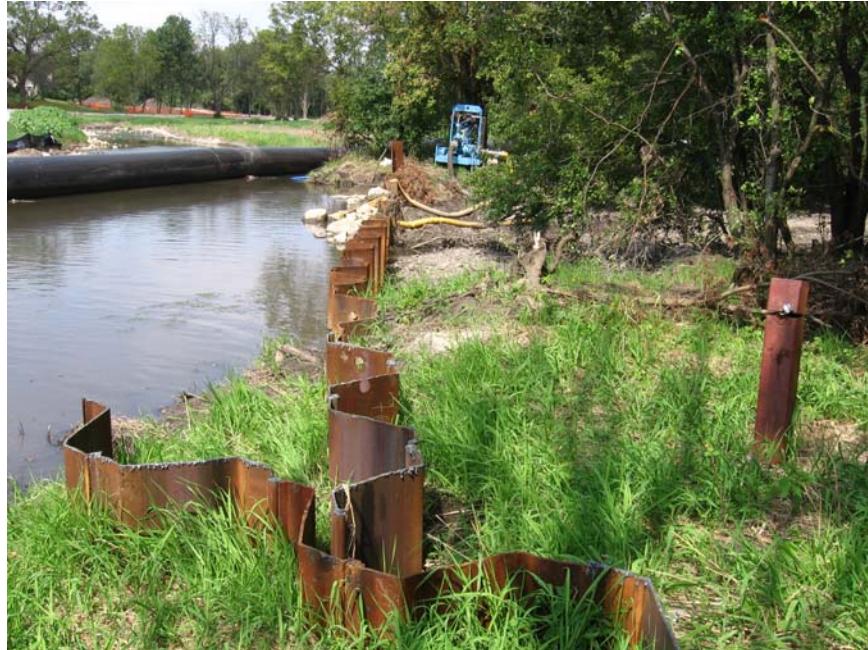
Looking at downstream backflow dam with bypass pipe in distance.

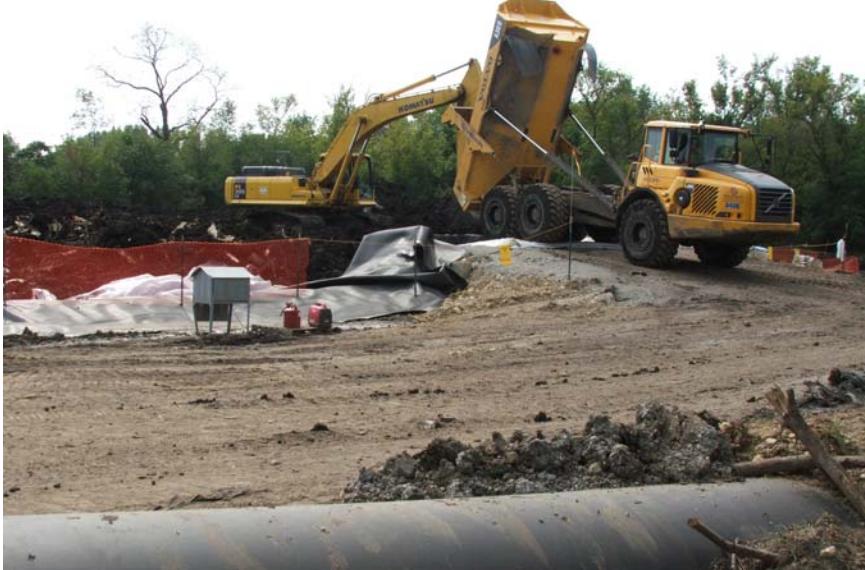
Direction: Looking east	
Comments: Off-road dump truck dumping excavated targeted material (TM) into the TM staging area.	
Photographer: Mike Savage Arcadis	
Date: September 9, 2006

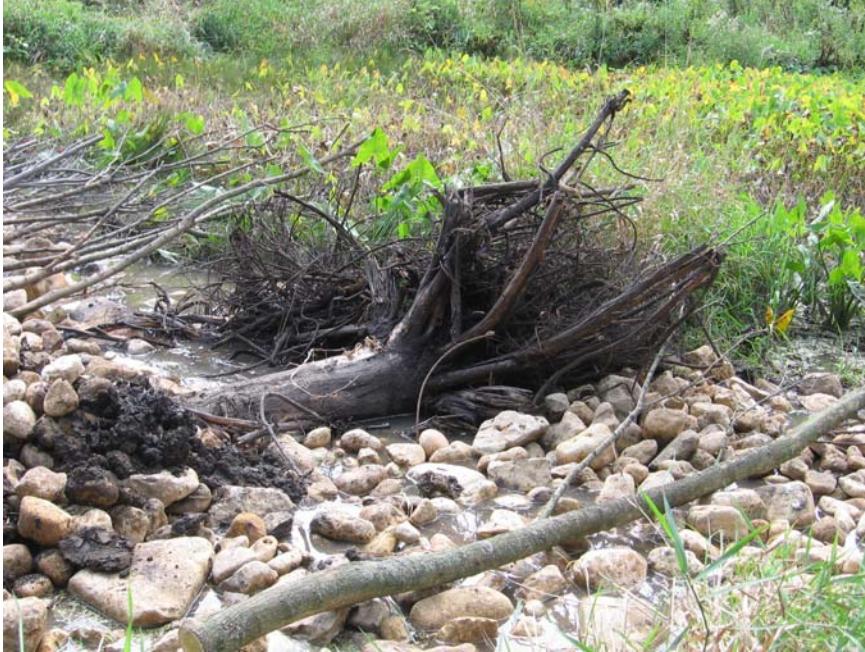
Direction: N/A	
Comments: Horizontal root wad installation into new crenulated bank.

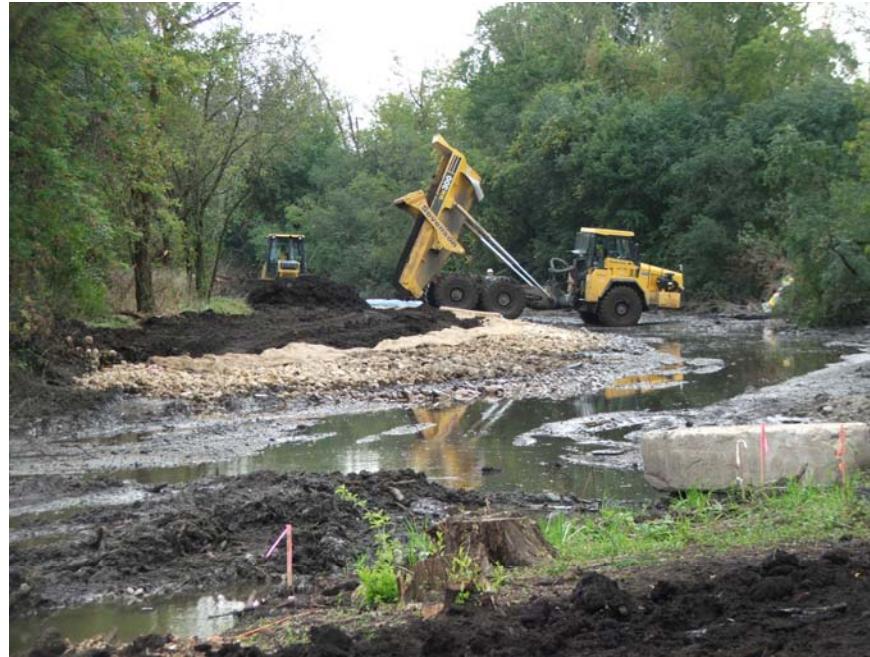
Hauling and placing
topsoil to final grade in a
completed excavation
area.

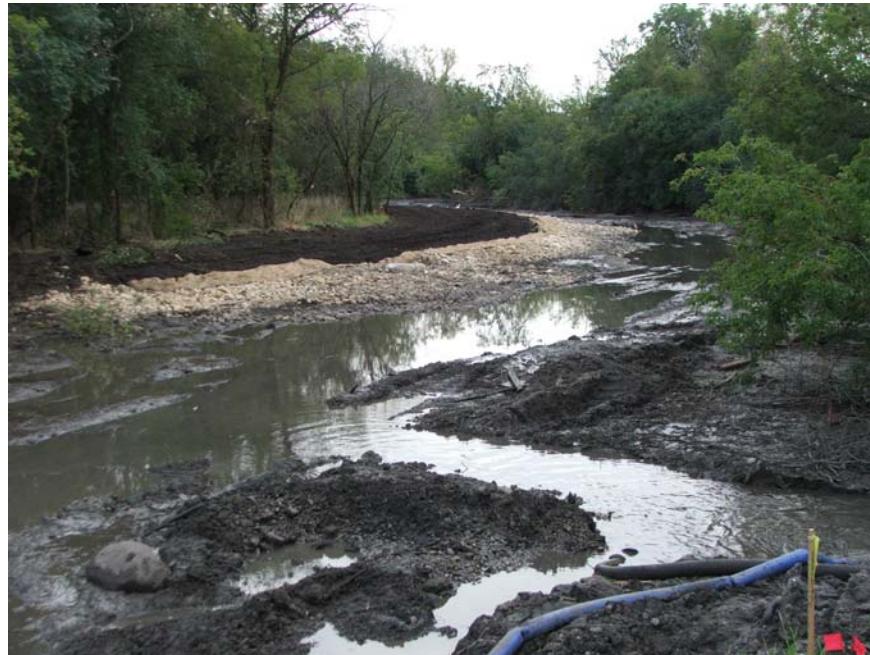
Completed section of
restored bank with river
rock application.

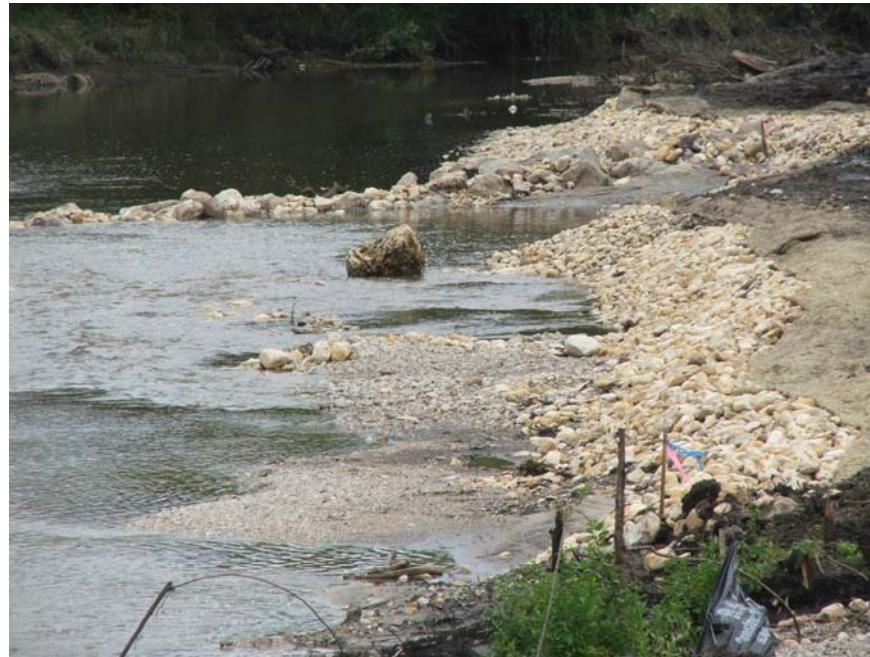
Installation of crenulated banks, bend way weir
and boulders.

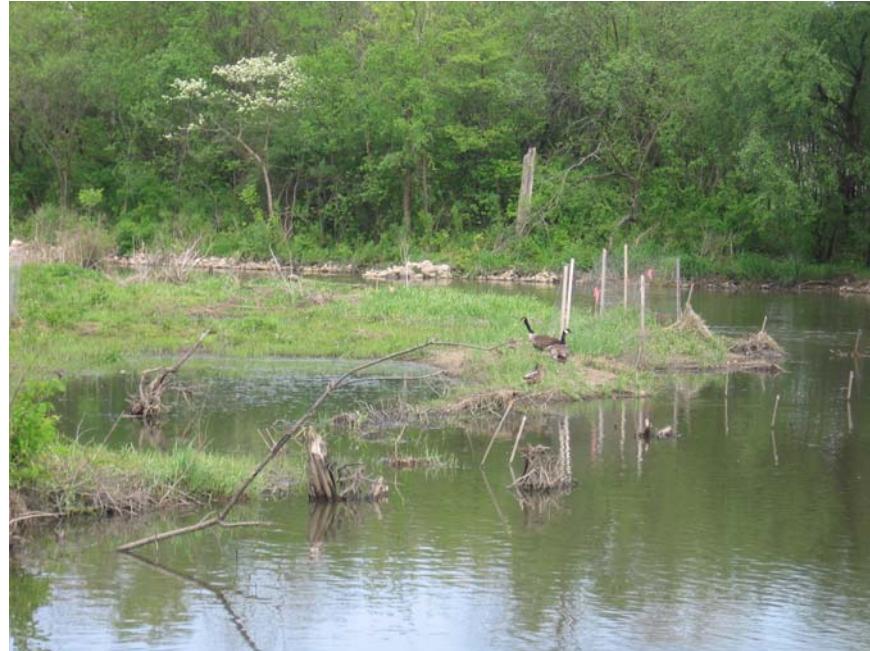
Looking at new
hummock and hollow
area on west bank in
center of Reach 5B.

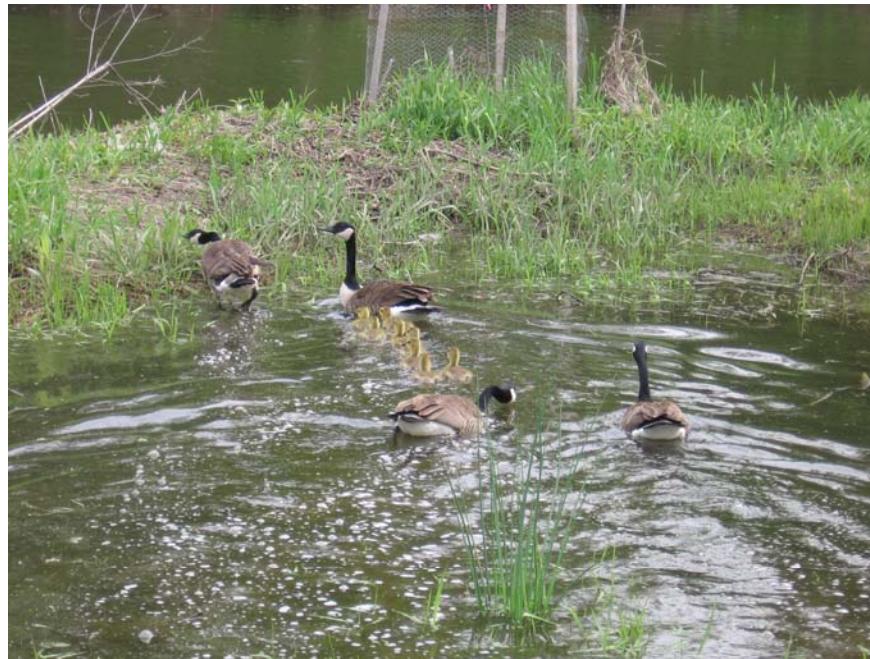
Canadian geese and goslings moved back in to new hummock in center of Reach 5B.
